ASSESSMENT OF THE TECHNICAL CONDITION OF THE KRASNOPAVLIVSK RESERVOIR EARTH DAM

**I.V. Voytovych¹, Ph.D., Ya.V. Shevchuk², O.M. Kozytskyi³, O.S. Ignatova⁴, G.Ya. Boyko⁵,
Yu.V. Limachov⁶**

The aim of research. Assessment of the technical condition of the structural elements of the earth dam of the Krasnopavlivsk reservoir.

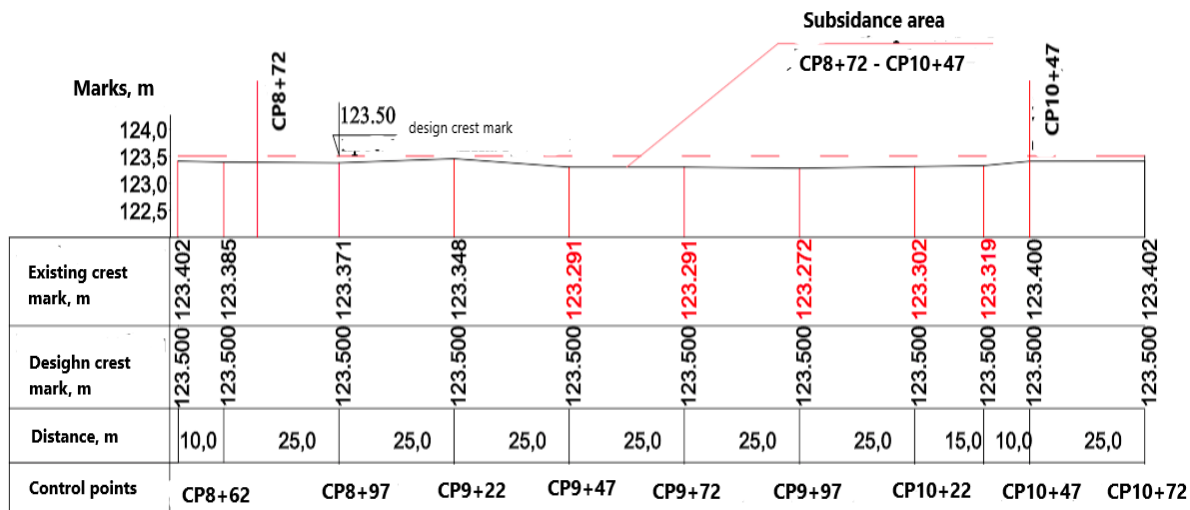
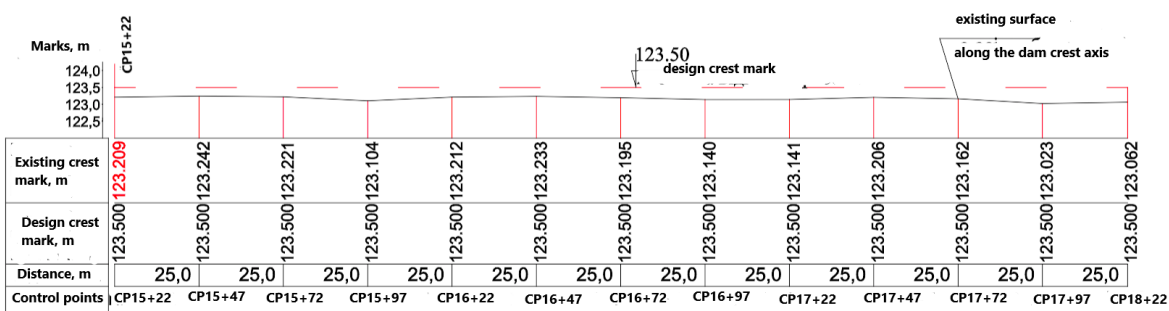
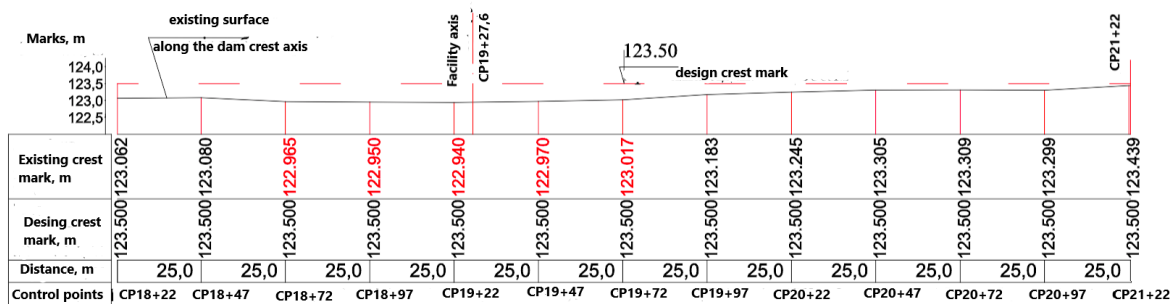
Fig. 2. Longitudinal profiles along the axis of the dam crest in areas of subsidence

To assess the deformation processes occurring in the dam body, a geodetic survey was performed. According to the survey results, the subsidence of the dam crest ranged from 35 cm (CP8+22–CP11+97) to 64 cm (CP15+22–CP 21+22) (Fig. 2).

a – CP8+72 – CP10+47; b – CP15+22 – CP18+22; c – CP18+22 – CP21+22

1. By instrumental studies we have determined the presence of the subsidence of the crest of the earth dam in two sections – CP8+22–CP11+97 and CP15+22–CP21+22, respectively, by 0,35 m and 0,64 m, which indicates a violation of the stability of the dam in these sections.

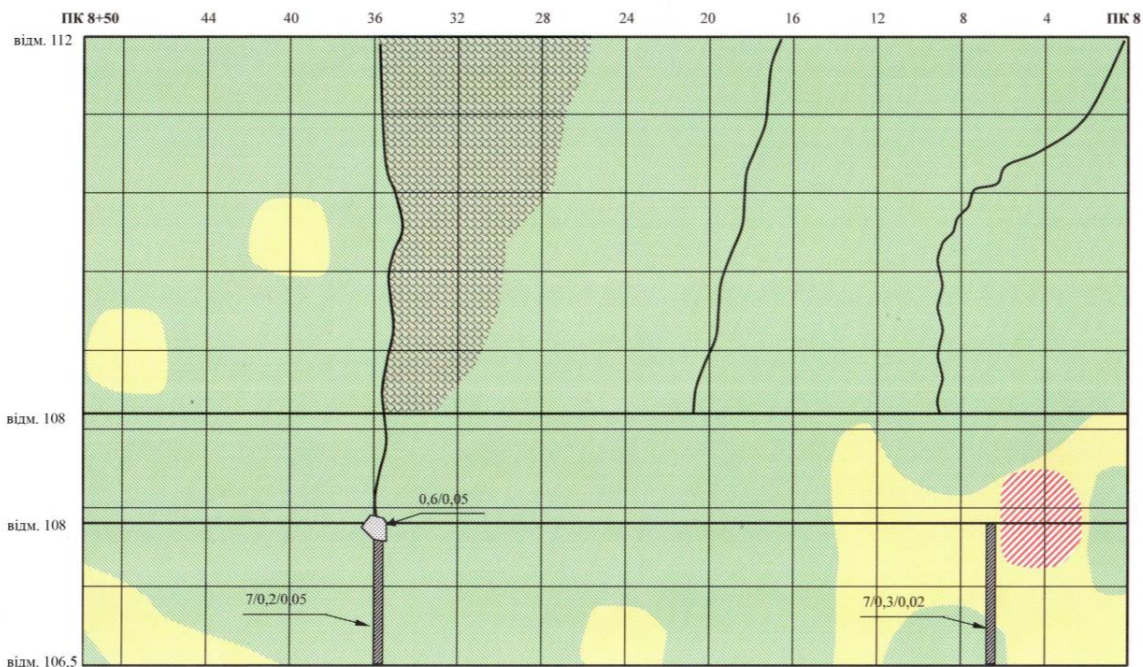
Fig. 4. Results of visual inspection and vibroacoustic diagnostics on CP8-CP8+50

diagnostics on CP8-CP8+50 are shown in Fig. 3, 4. In Fig. 4, the area of cavity formation under the concrete coating is marked in red.

The formation of voids under the concrete facing of the upper slope is due to the manifestation of suffosion processes of removal of the underlying sand layer as a result of overmoistening due to the pressure filtration through deformation-temperature joints and cracks in monolithic concrete.

Based on the materials of the conducted surveys, the areas and volumes of voids under the concrete covering of the upper slope at the elevations of 106.5–112.0 m of the CP8-CP10 section, and the category of destruction were determined (Table 1).

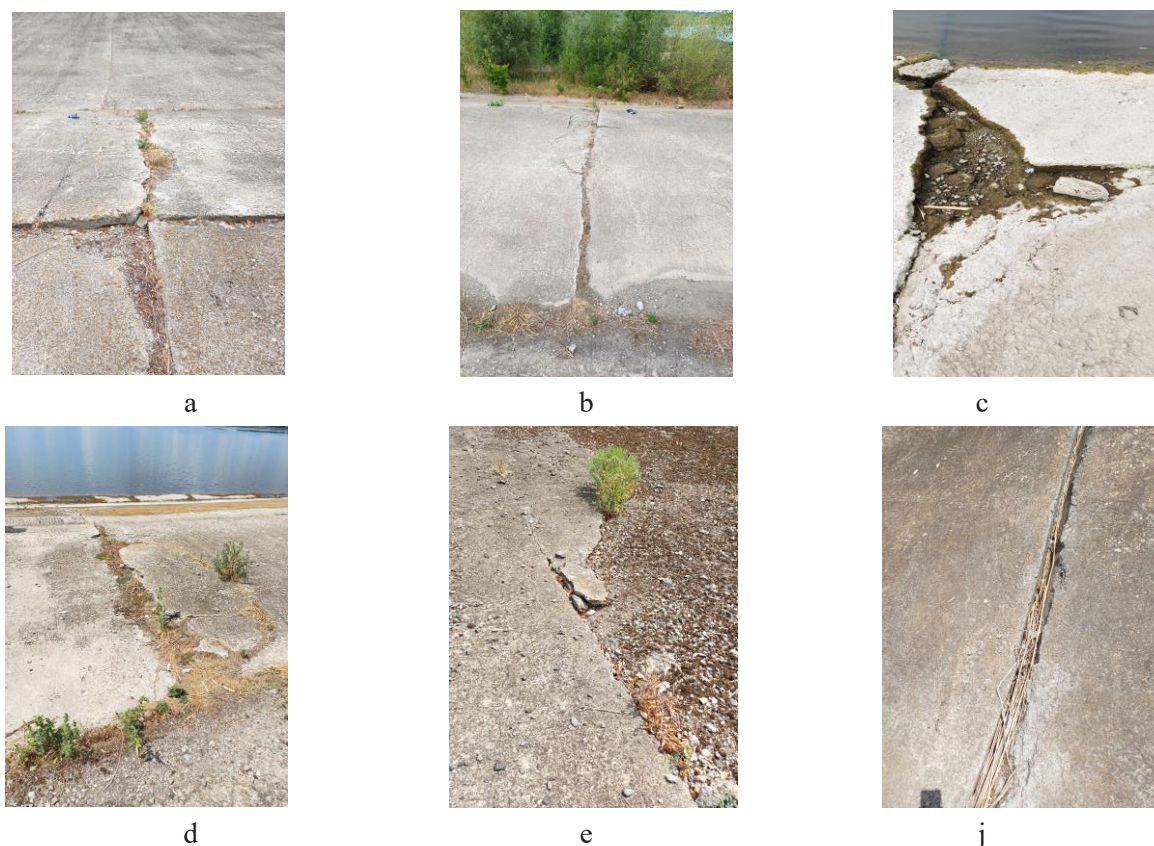
Fig. 5. Detected damage to the concrete covering of the upper slope of the dam

a – local destruction of expansion joints; b – formation of cracks; c – local spalling of concrete; d – destruction of structural joints; e – corrosion of the concrete surface; f – decompression of temperature-deformation joints

2. Typical destructions of reinforced concrete covering are the destruction of temperature-deformation joints as a result of a failure of

wooden fillings; the presence of transverse and longitudinal cracks in the reinforced concrete covering as a result of a decrease in the stability of the fastening base, which is caused by the development of filtration processes (mechanical suffosion) and the removal of particles from the sand cushion ($h=0,35$ m); the corrosion and local destruction of concrete.

3. The crack openings, the size of which reaches up to 3,0 cm, are due to the presence of deformation processes of the base of the underlying layer of concrete reinforcement, as a result of which cracks form in the concrete coating down to a depth of up to 25 cm.

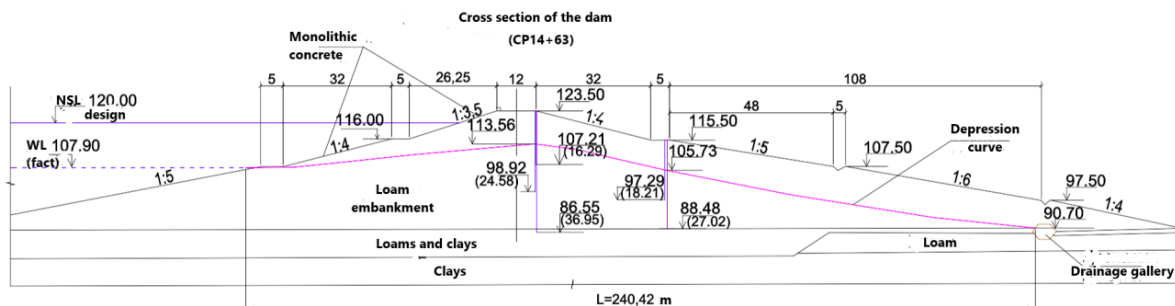
Fig. 7. Calculation scheme for determining the average pressure gradient

which corresponds to 90,60–90,70 m [17]. As an example, Figure 7 shows the calculation diagram of the position of the depression curve along the line1 (CP14+63).

As can be seen from Table 3, the head gradient of the earth dam as of September 8, 2024 is from 0,076 (line 1) to 0,07 (line 2) – which is significantly less than critical and indicates a safe filtration mode of the dam.
