HYDROMORPHOLOGICAL ASSESSMENTS AT THE IRPIN RIVER – METHODOLOGICAL HINTS AND FIRST FINDINGS

M. HOFFMANN, Doctor of Natural Sciences

Practical hints are given to ease the planning and implementation of habitat assessments in terms of hydromorphological elements as described in the WFD. A reach of the r. Irpin, located between 2 impoundments, was classified as partly moderate and partly good

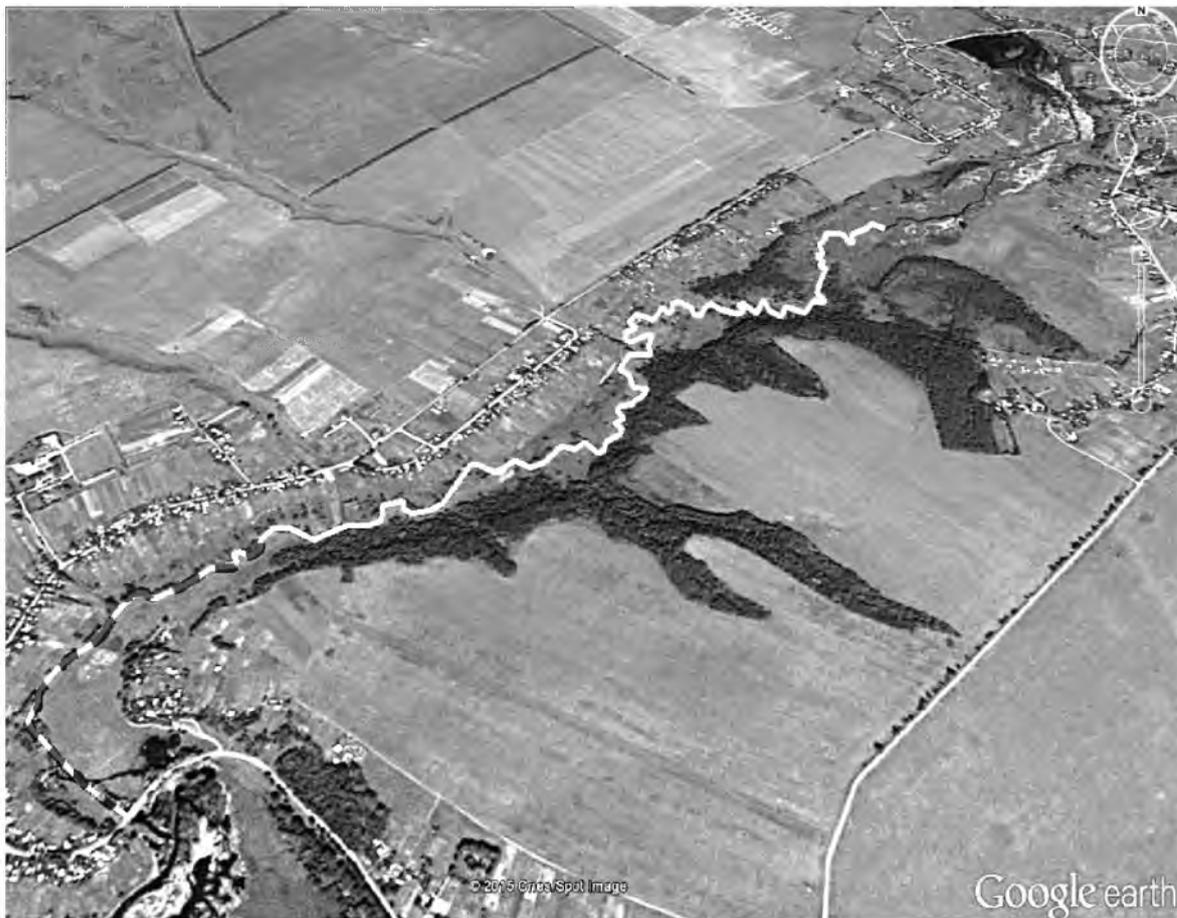
habitat structures. It is obvious that the river course has been changed in the first km section beginning at the weir in Didivshchyna while thereafter the river meanders downstream until it reaches the next impoundment near Tomashiv-

ka. This is one of the main reasons why the ecological potential of the river reach was classified as moderate (white/black striped on figure 2) and further downstream as good (white colour).

Fig. 2. Hydromorphological classification of the river reach between Didivshchyna and Tomashivka, Kyiv Oblast (colour codes: striped line – moderate, solid white line – good potential)

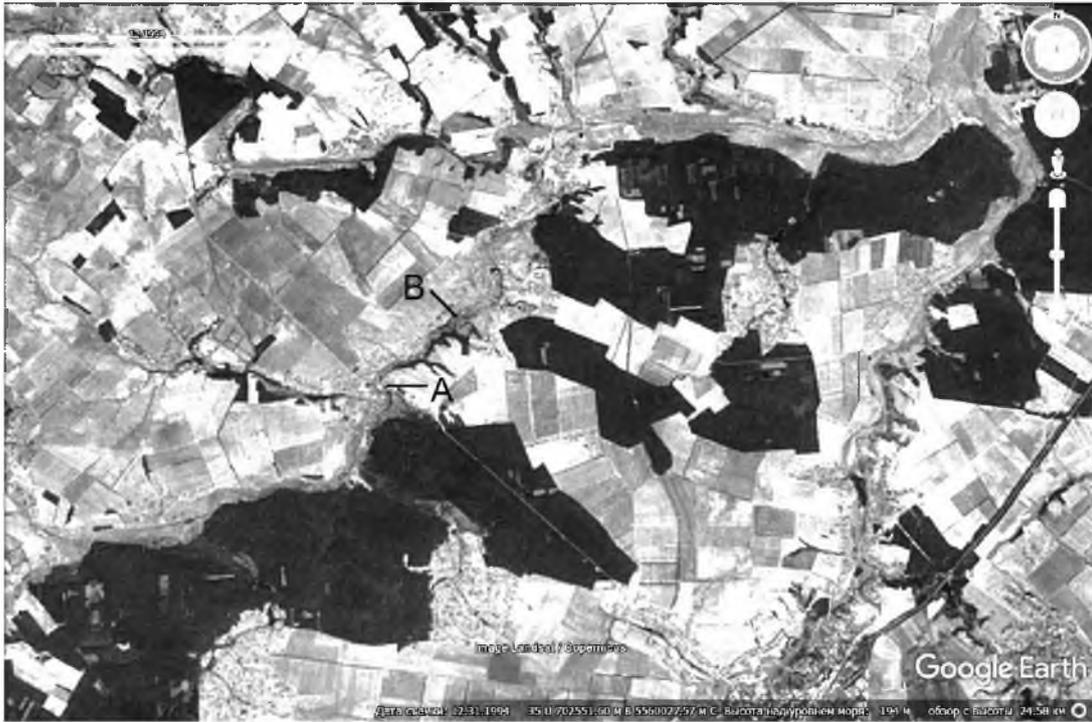
Agricultural landuse is unevenly distributed in the subbasin. As can be seen on figure 3 and 4, the share of forest has decreased during the

(fig. 3 and 4) suggest however that the share of pastures has significantly decreased over the last 22 years (1992-2015).

Fig. 3. Google Earth image taken on December 1992, converted to black and white colour
The starting point of the investigated reach (in the image centre) is marked with "A" (coordinates: UTM (35) 5'559'083 mE; 698'224 mN), the end point is "B" (UTM (35) 5'561'150 mE; 700233 mN), height difference ca. 5m. Forests are in dark gray or black colour, agricultural areas in white or light gray, villages are speckled.

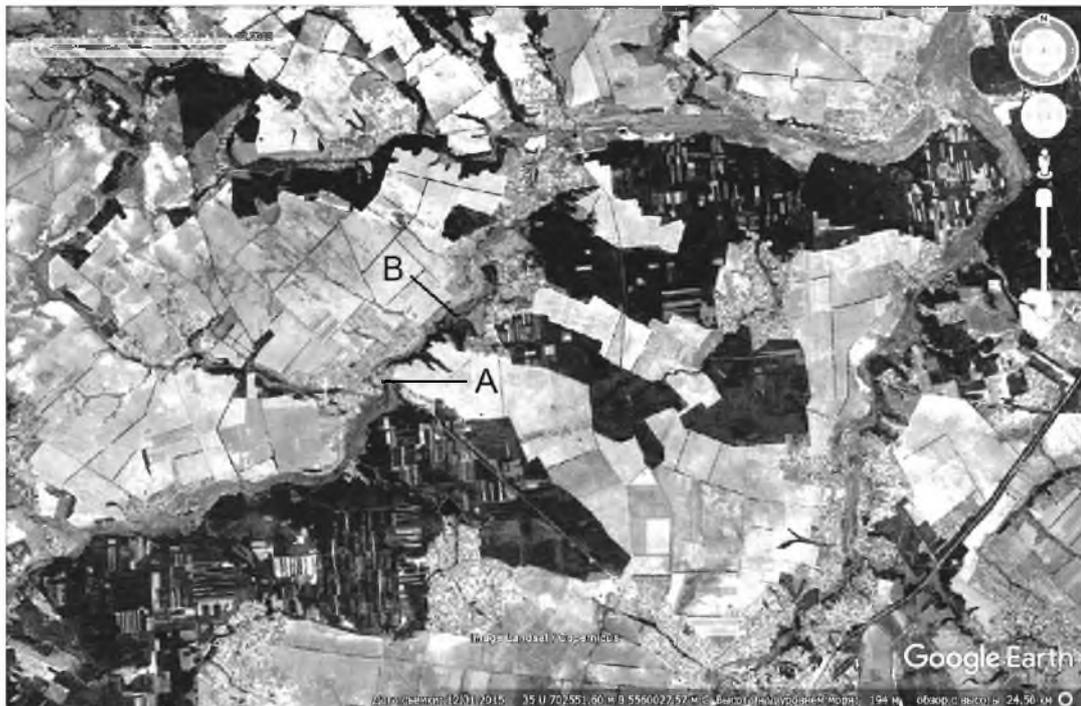
Fig. 4. Google Earth image taken on December 2015; coordinates as in figure 3
