ASSESSMENT OF THE CURRENT ECOLOGICAL STATE OF THE FASTIV RESERVOIR USING GROUND AND SATELLITE DATA

Abstract. *The article presents the results of researches on assessing the ecological state of the Fastiv Reservoir using ground and satellite data according to the developed scientific approach, which provides for the following sequence for a water body with a large area: conducting field observations, involving satellite information, and creating a resulting map of the current ecological state based on a certain set of indicators, which is the goal of the research. The relevance of the research is defined by the significant deterioration of the water condition in the reservoir, which was caused by an increase in air temperature, uneven distribution of precipitation throughout the year, a decrease in the reservoir filling to 92.7 % of the design level, intensive increase in water use and discharge of domestic wastewater. In the conducted studies, it was advisable to compensate the lack of spatially concentrated information (from points of field measurements) with spatially distributed information. During field surveys, hydrobiological and physicochemical indicators were determined i

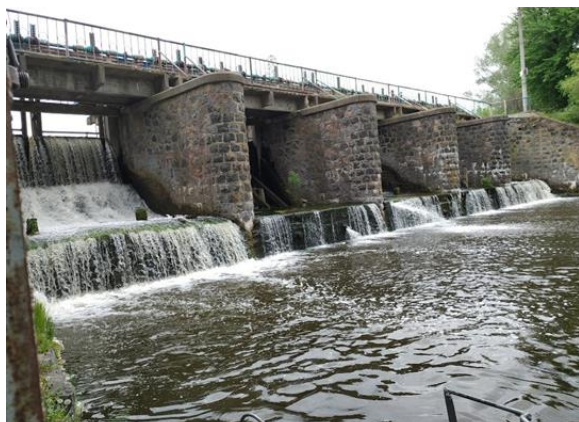
city. During the operation time of the reservoir, the hydraulic facilities were reconstructed in 1929, 1932, 1961, and 1998. Over the past 15-25 years, flow regulation by gates has been practically not carried out, which has led to significant silting of the reservoir. According to the results of the survey of the reservoir by the specialists from the Institute of Water Problems and Reclamation of the National Academy of Agrarian Sciences (IWPiM of NAAS) in August 2022, it was noted that the water level in the reservoir was below the NSWL and the regulated volume of water in the reservoir was 4.69 million m³, which is 92.7 % of the reservoir's design capacity. The main reason for the decrease in the reservoir filling was low water conditions of the current year on the background of significant filtration losses through the hydraulic facility, which is due to the unreliable operation of the gate valves (Fig. 1).

Figure 1. Hydraulic facility of the Fastiv Reservoir

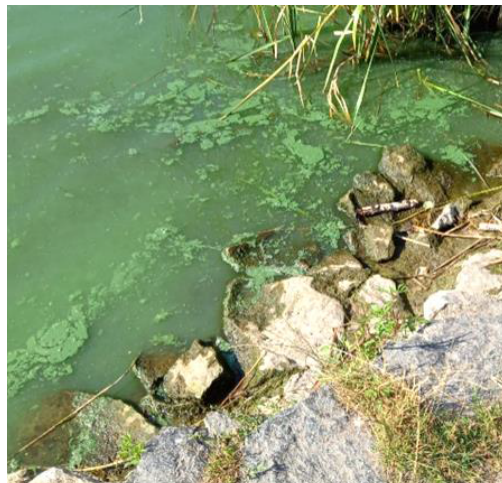
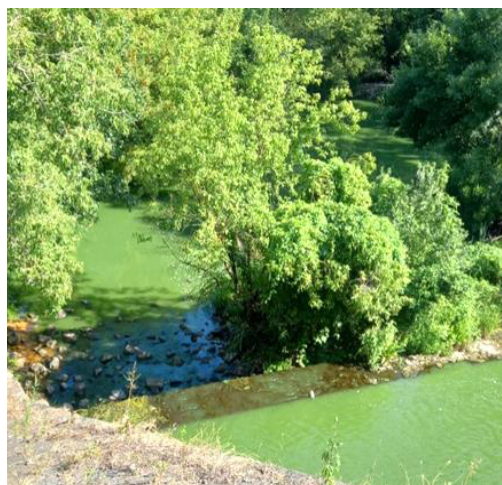
water legislation in the work of the communal enterprise “Fastivvodokanal”. Such violations contributed to the increase in water “bloom” (Fig. 2) from year to year.

Figure 2. Water pollution in the Fastiv Reservoir: a – upstream, b – downstream.

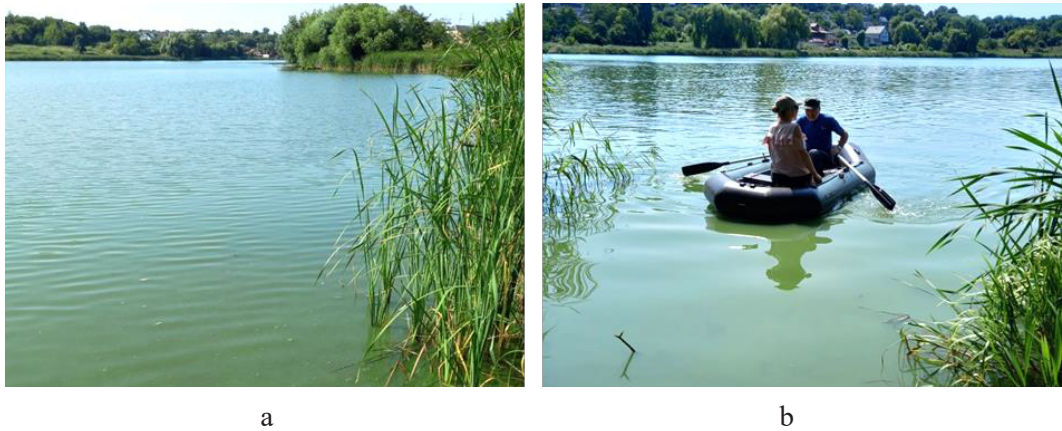
During the survey (Fig. 4), depth measurements, water sampling, and measurements of transparency, turbidity (content of suspended solids), color, and water temperature were performed.

Figure 4. Survey conducting: a – the upperstream; b – using a boat to measure the depth of water and take water samples

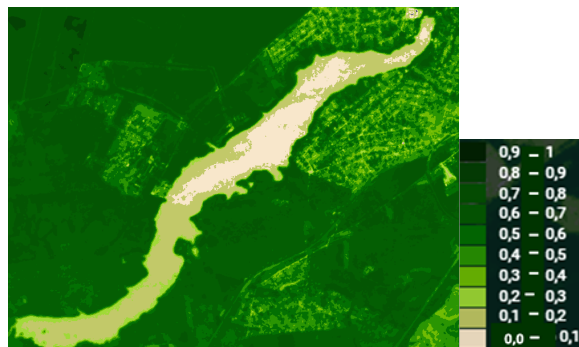
Figure 6. Map of NDVI distribution within the Fastiv Reservoir

For the study we used the Sentinel-2 L2A image dated 25.07.2024, the closest date with no cloud cover to the date of field surveys, and calculated the following spectral indices in the open software product LandViewer: Green Chlorophyll Index (GCI), Normalized Difference Water Index (NDWI) [8, 9, 10], Normalized Difference Vegetation Index (NDVI) [11]. Based on the results of the calculations, maps of these indices were obtained (Fig. 6–8).

The classical NDVI map distinguishes coastal vegetation – reeds in the range of 0,30–0,40 microns and finely dispersed impurities in the water in the range of 0–0,10 microns. The GCI map is not informative, since it only concerns vegetation, and on the surface of the reservoir it is absent, and gives only clear contours of the reservoir itself. However, the NDWI map is obtained by the calculation that uses the near-infrared (NIR) band with a wavelength range of 0,78–0,90 microns and the mid-infrared (SWIR) band with a wavelength range of 1,56–1,66 microns, provides the most information about the trophic state of the reservoir. With an NDWI value above 0,3, an open body of water is distinguished; the values from 0 to 0,3 shows the presence of vegetation with a high water content or partially submerged areas of vegetation; a value of 0 usually indicates dry soil or vegetation with a low water content. It is important to note that these threshold values can vary depending on the specific environment and should be calibrated according to local conditions. Thus, during the research, more information about transparency was obtained, which made it possible to produce a resulting map of the current ecological state of the Fastiv Reservoir (Fig. 9) based on ground and satellite data.

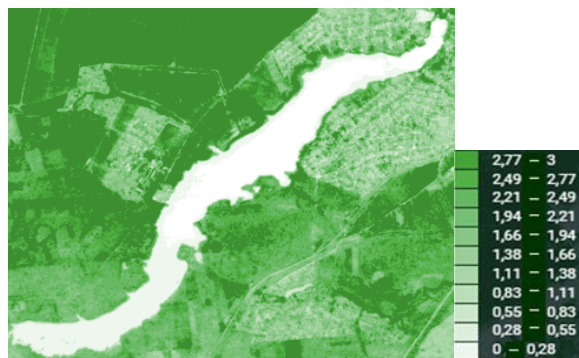
Figure 7. Map of GCI distribution within the Fastiv Reservoir

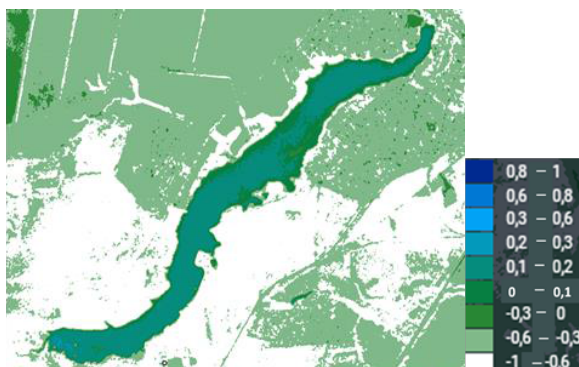
Figure 8. Map of NDWI distribution within the Fastiv Reservoir
