ASSESSMENT OF THE TECHNICAL CONDITION OF THE KRASNOPAVLIVSK RESERVOIR EARTH DAM

**I.V. Voytovych¹, Ph.D., Ya.V. Shevchuk², O.M. Kozytskyi³, O.S. Ignatova⁴, G.Ya. Boyko⁵,
Yu.V. Limachov⁶**

The aim of research. Assessment of the technical condition of the structural elements of the earth dam of the Krasnopavlivsk reservoir.

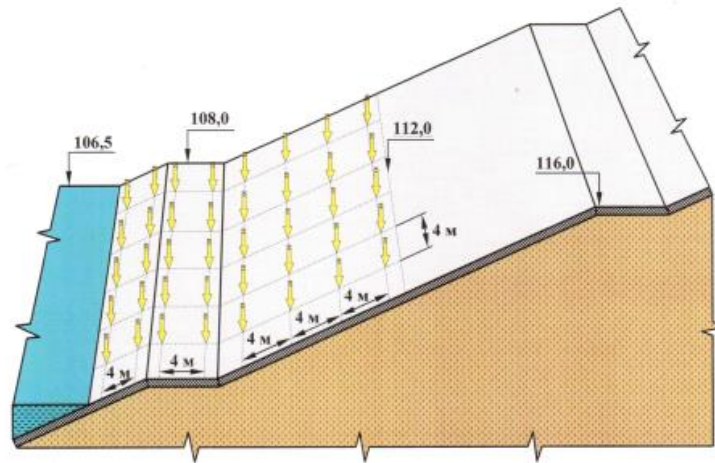
Fig. 3. Layout of cross-section bases during diagnostics of the earth dam body

diagnostics on CP8-CP8+50 are shown in Fig. 3, 4. In Fig. 4, the area of cavity formation under the concrete coating is marked in red.

Geophysical studies to determine anomalous processes along the underlying layer of the earth dam's concrete foundation were performed using the VIY5 600 Georadar instrument at CP8-CP8+50. The probing depth can reach up to 3,5 meters.
